Re: Notice of Violation  
Reserve at Alaquia Subdivision  
National Pollutant Discharge Elimination System Permit No.: FLR100000  
Identification Number: FLR10NV66

U.S. Environmental Protection Agency, Region 4  
61 Forsyth Street SW, Atlanta, GA 30303  
**Water Compliance Inspection Report**

### Standard Pacific's The Reserve at Alaqua Stormwater Inspection FLR10NV66

March 25, 2015  
US EPA - Region 4

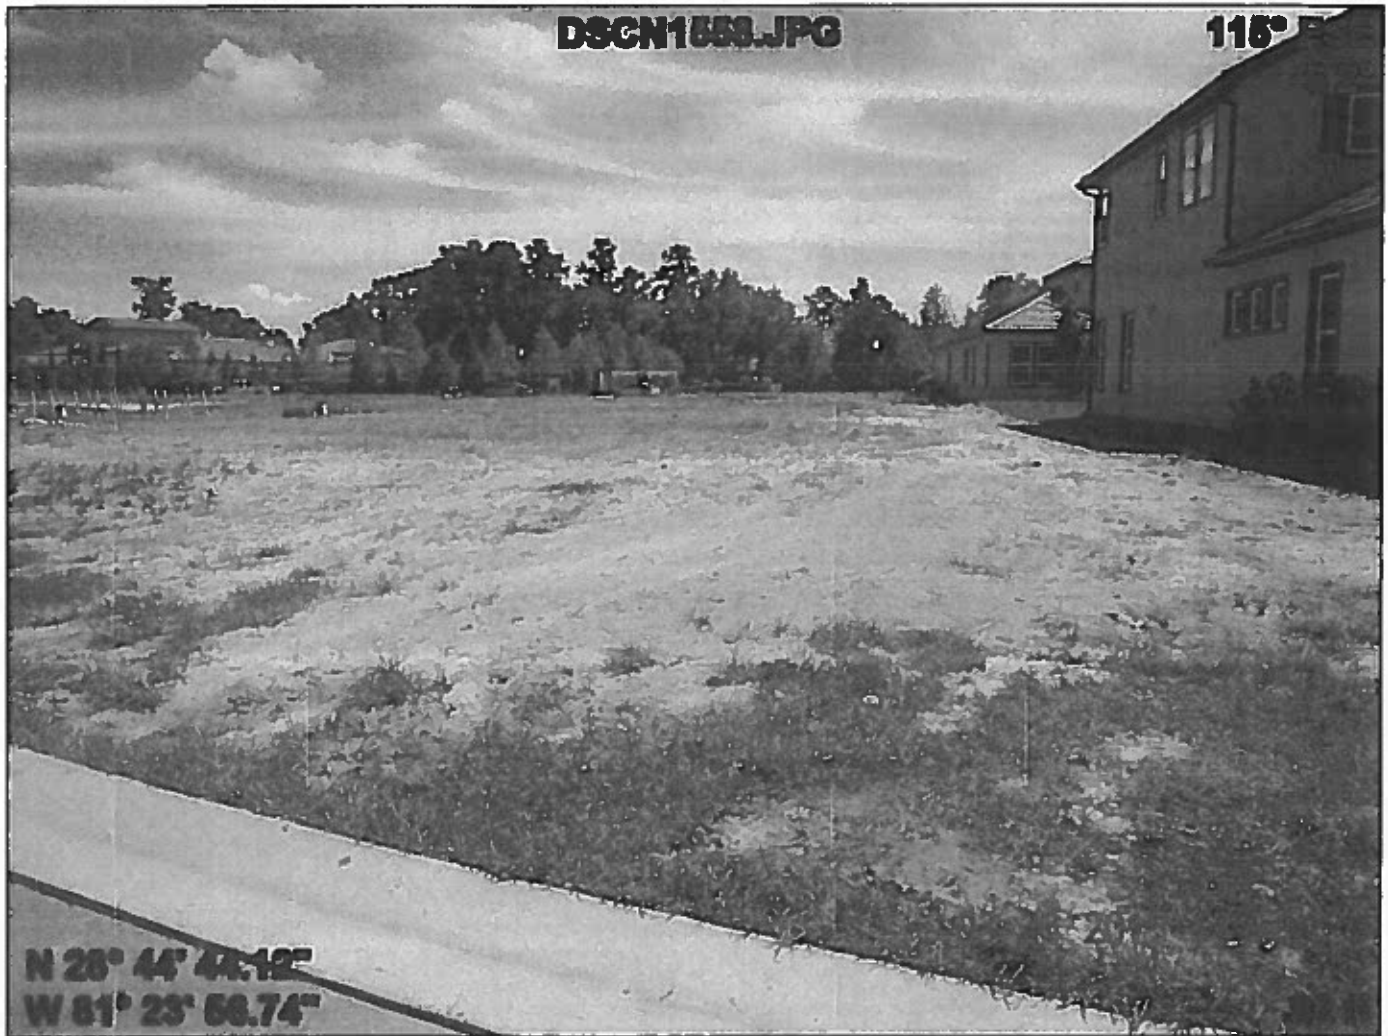
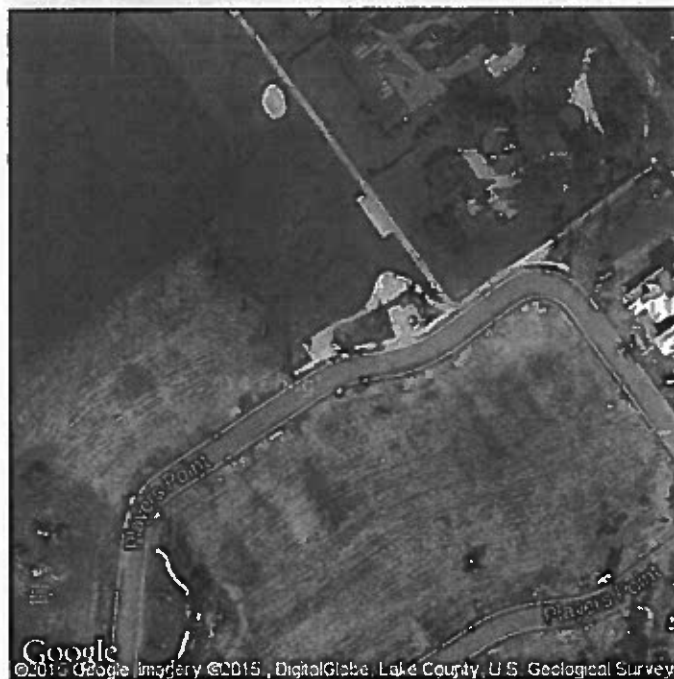
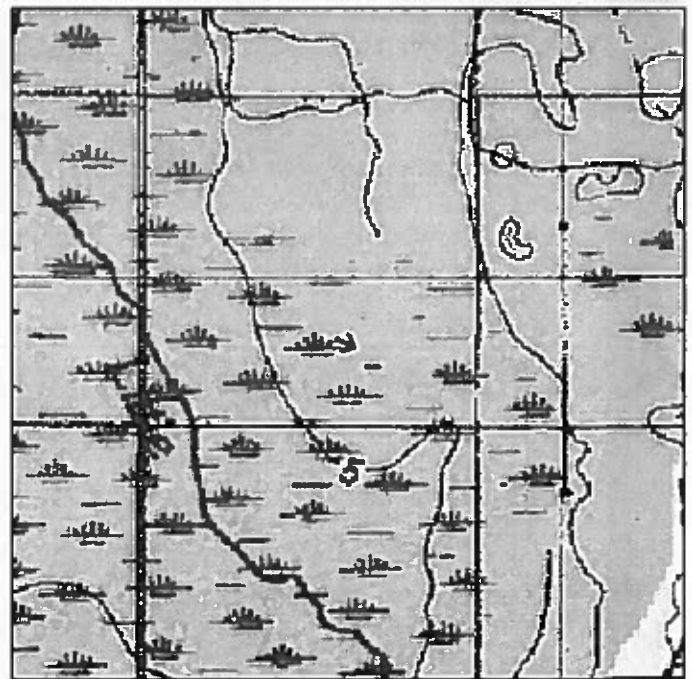
Description: undeveloped Lot #19 with marginal BMP curb.

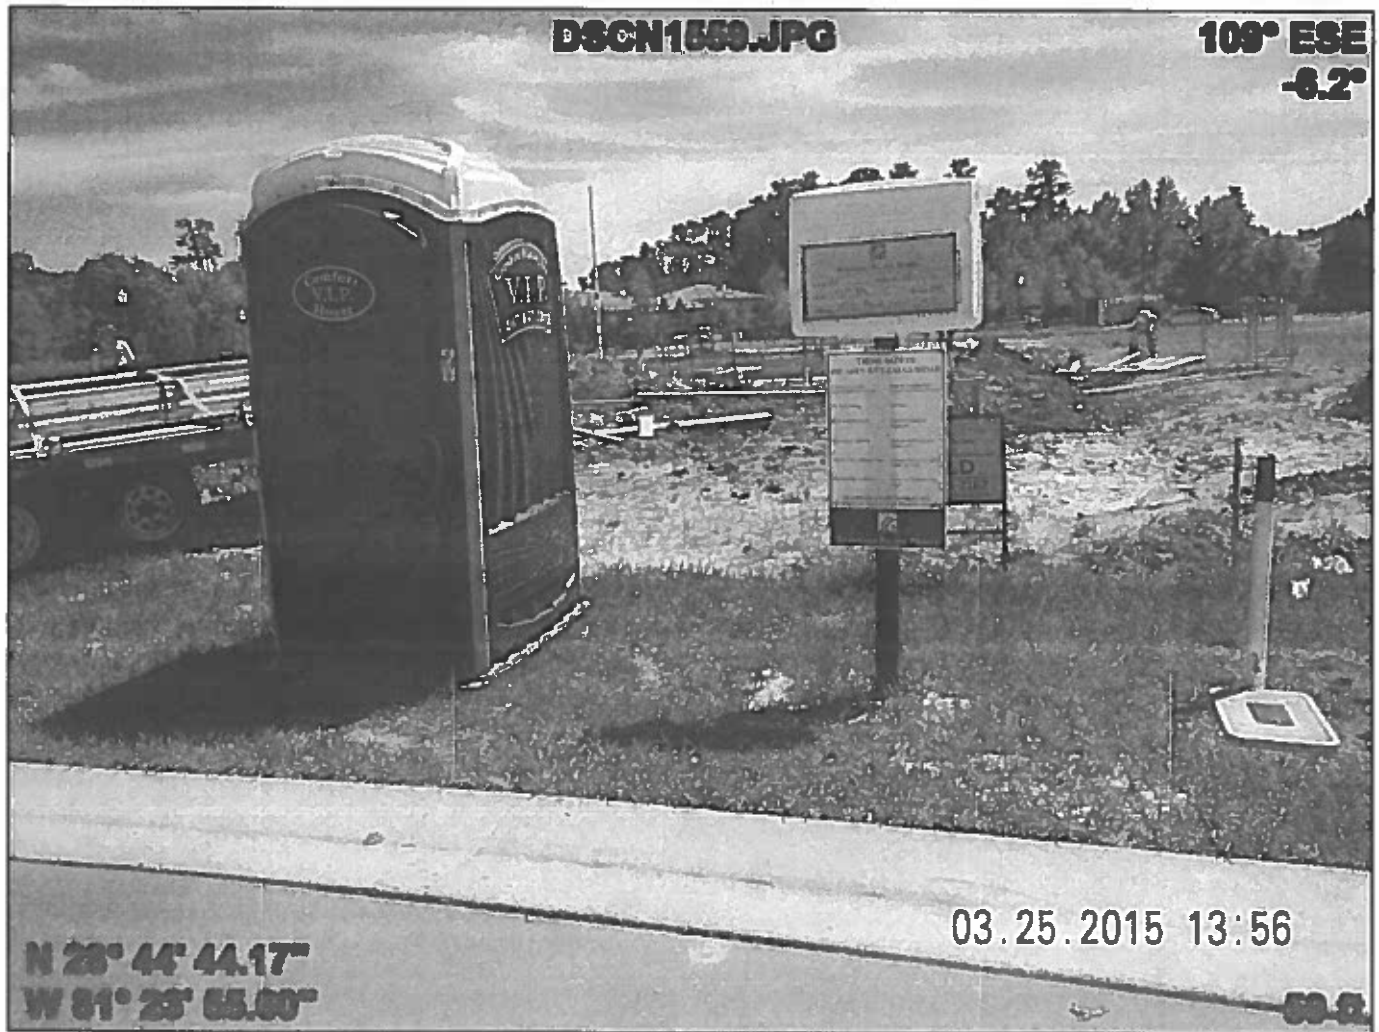
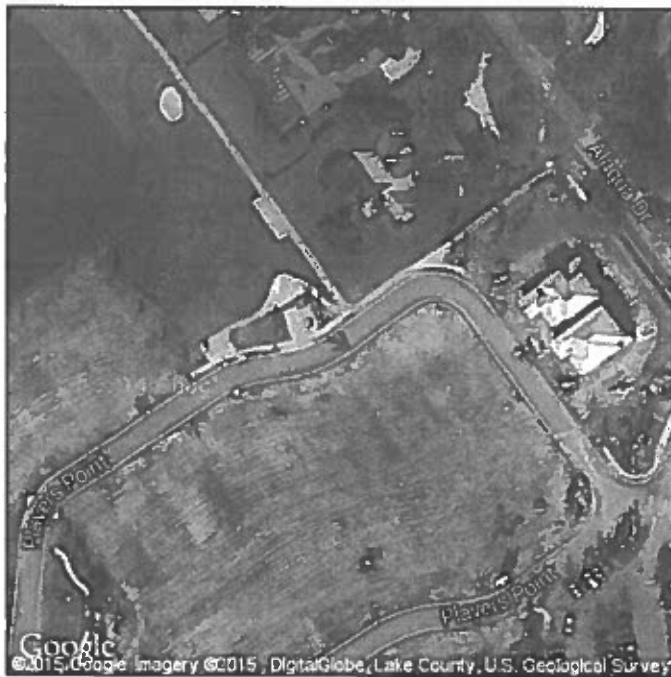
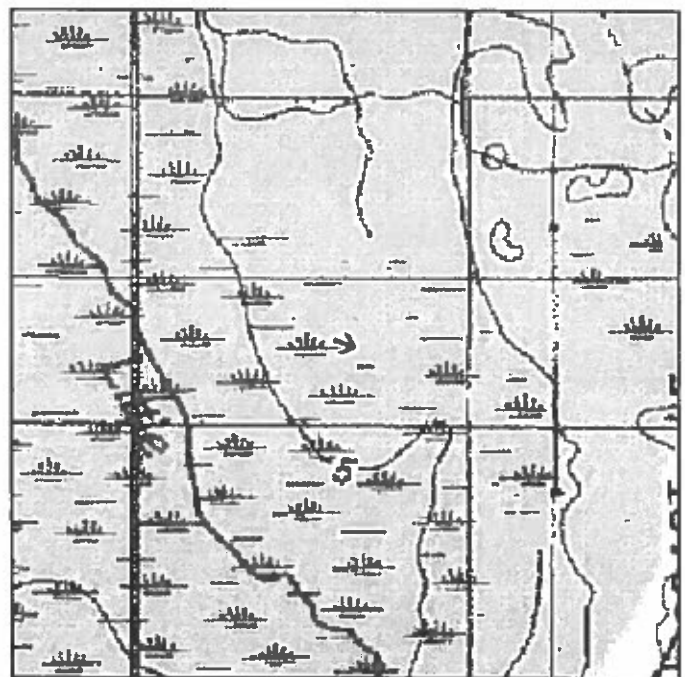
Description: portable toilet within 5 feet of curb at Lot #21.
